VOLUME ONE

Thanks to Keith Abrehart , Sheldon Bardin and Robert Davis for bringing the various European items in this update to my attention as well as for providing photos of them. And thanks to Walter Smith and other contributors for their assistance regarding, and photos of, U.S. vehicle components

February 5, 2021

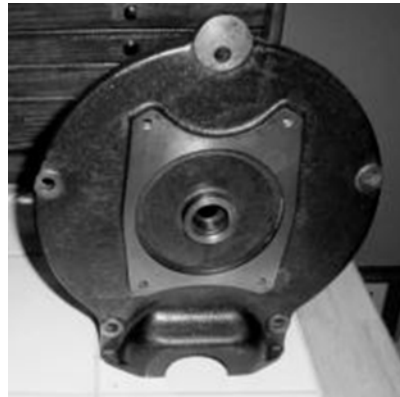
Chapter 1 Page 5 An example of the initial V-8 timing gear cover used with the four bolt distributor that was replaced as part of the April 22, 1932 service campaign (recall) discussed in Chapter 3. The notice of the campaign to the branches included instructions that the replaced components be returned to the Rouge Plant where they were subsequently scrapped. This one escaped the fate of nearly all of the other examples as it is the only survivor known to the author outside of “the Henry Ford” (Museum).

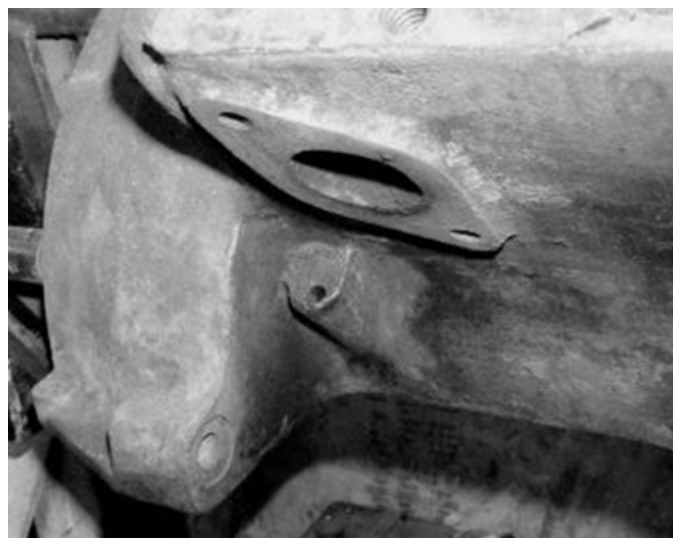
The photo below is a close up of the area of the last version of the V8 cylinder block casting where the oil dipstick was located in the block itself on the right side above the starter motor like that in the photo of W.R. Campbell stamping C18D-1 on this page. The cylinder blocks in both photos have cast-in holes for the attachment of the engine steady rods, unlike the first version where separate brackets were bolted to flat areas on the sides of the bell housing as with the four cylinder engines.

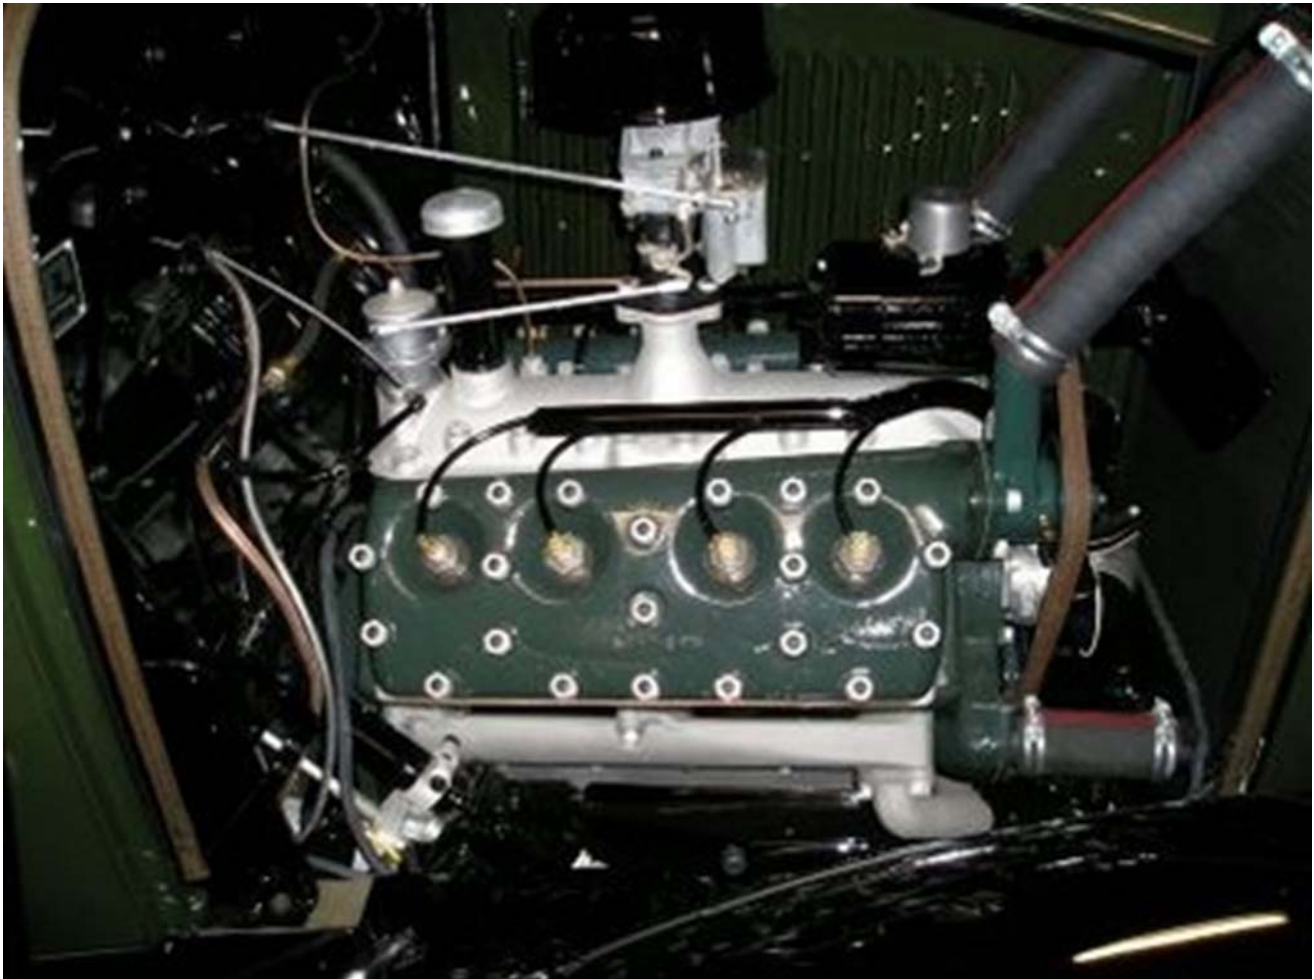
That none of the Ford's engineers responsible for the design of the engine block realized that such a dipstick location was a really bad choice when the engines were installed in RHD is a mystery given the Company's long history of producing RHD vehicles in both Canada and the United States (for export) and in Australia and the United Kingdom. In a finished vehicle it is a real challenge to remove and replace the dipstick to check the oil level in the oil pan without distorting the dipstick and chipping the paint on the steering column tube in the process.

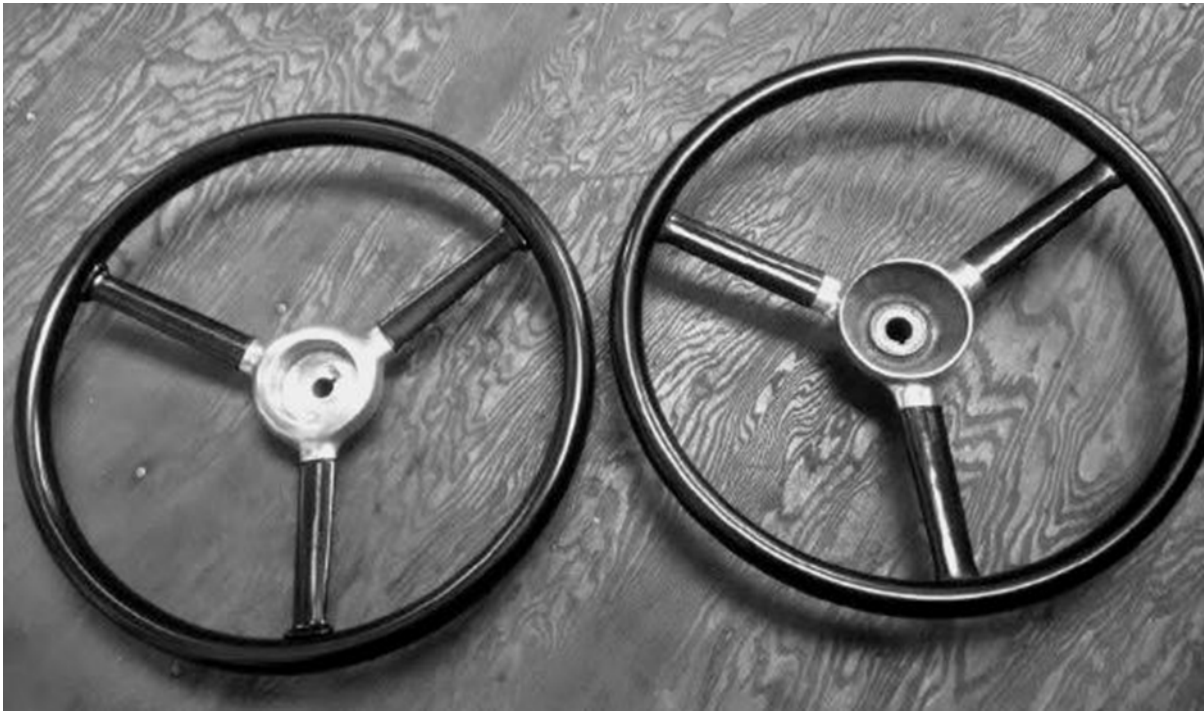
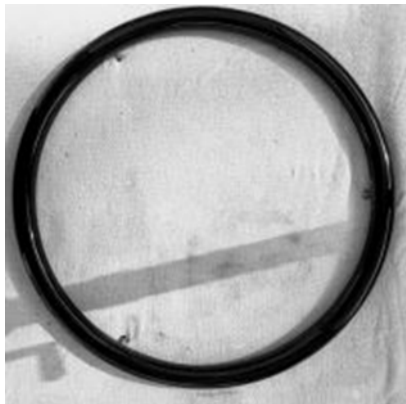
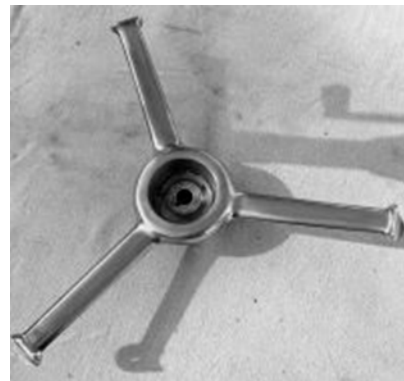
Chapter 4 Page 19 There were two versions of the British two-piece steering wheel. On the left in the photo below is the version used on conventional '32s while the wheel on the right was used on the later Model 14s with the difference being in the shape of the hub reflecting

reflecting the '33-'34 style light switch plate/horn button used on the Model 14s.

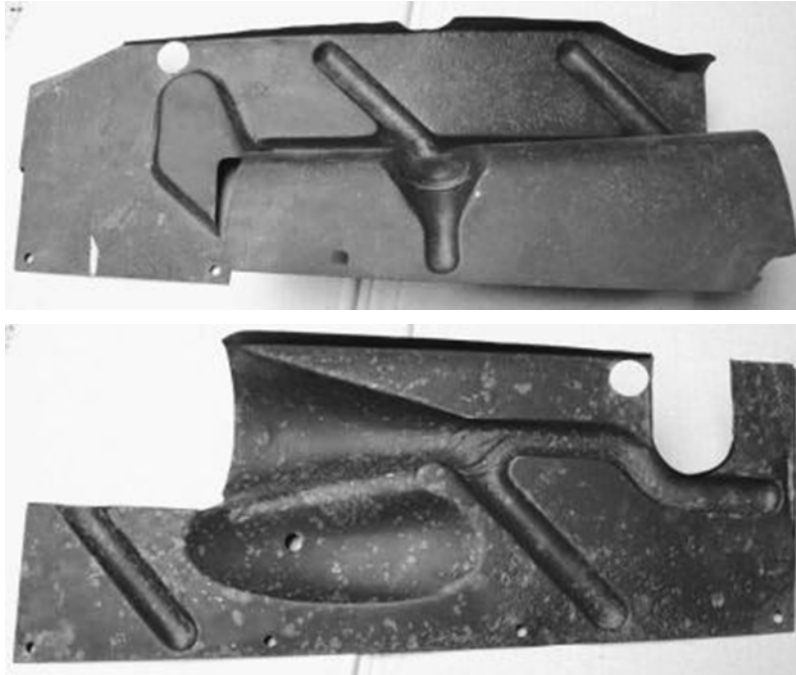
Chapter 5 Page 18

The late version of the RHD left side V8 engine splash pan is shown on top below and the previous version for the RHD right side is below. These were removed from the same car giving further evidence that Ford did not adhere to matching pairs of components until existing inventories of previous versions had been exhausted.

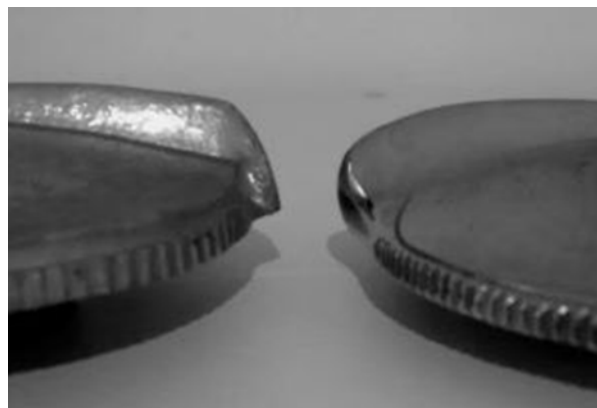
Page 31

The difference in the rear profile of these radiator caps from Europe suggest that at least two different suppliers were used by Ford in European production.

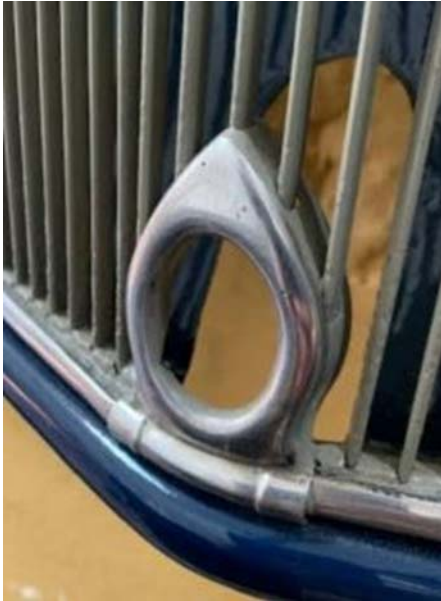
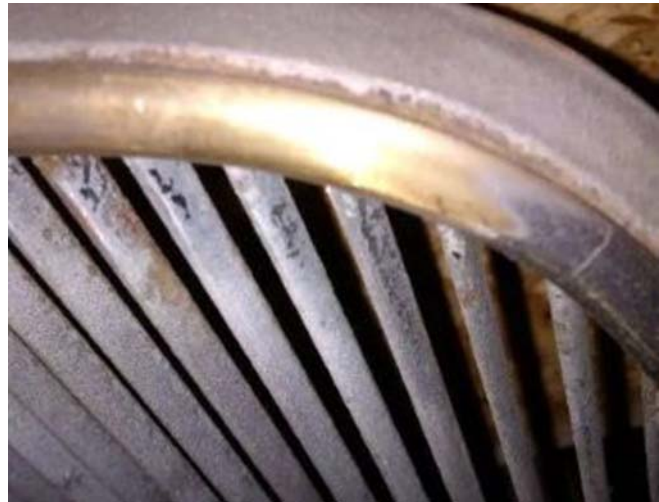
Page 32 32 In the photo on the left is another variation of the shape of the hand crank access hole stamping at the bottom of the grille. This is on a European grille. Another European grille variation is shown on the right where the outer molding of the grille is chrome-plated brass, not stainless steel.

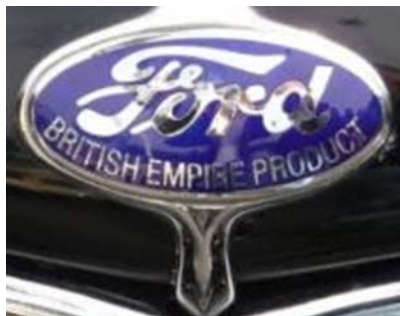
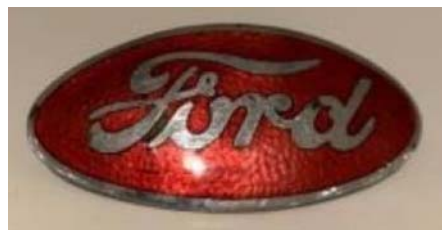
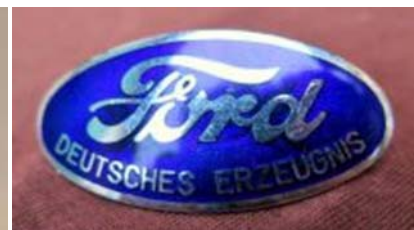
Page 33 Two Ford of Britain cloisonne radiator shell emblems are shown on the left and center below and a German variation from Ford Werke on the right.

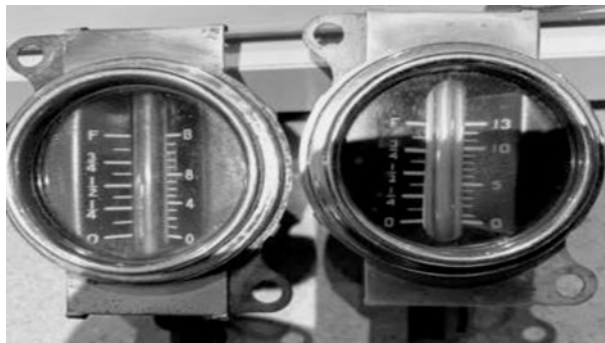
Page 41 Fuel gauge face variations found on European vehicles.

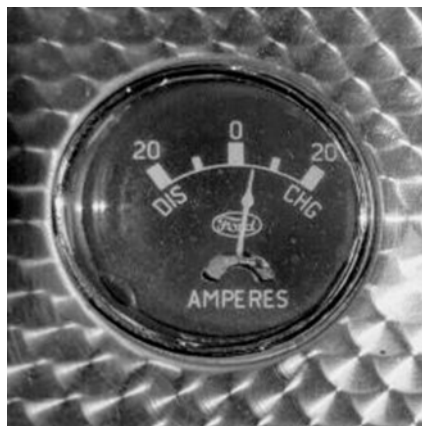
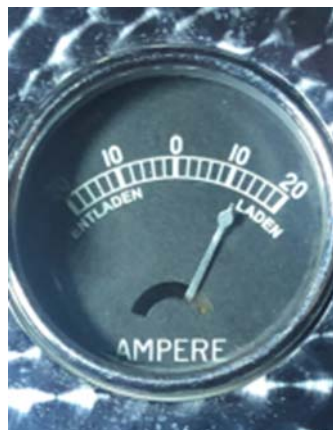
Chapter 6 Page 6 Ford of Britain and Ford Werke ammeters.

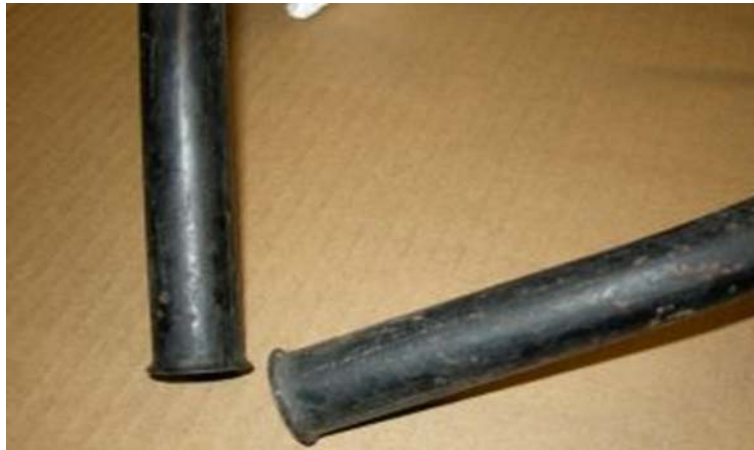
Page 17 The front ends of 1932-only V8 spark plug wire conduits.

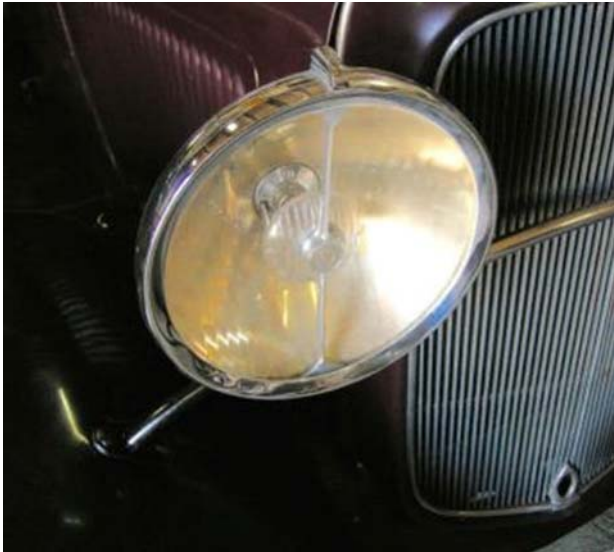
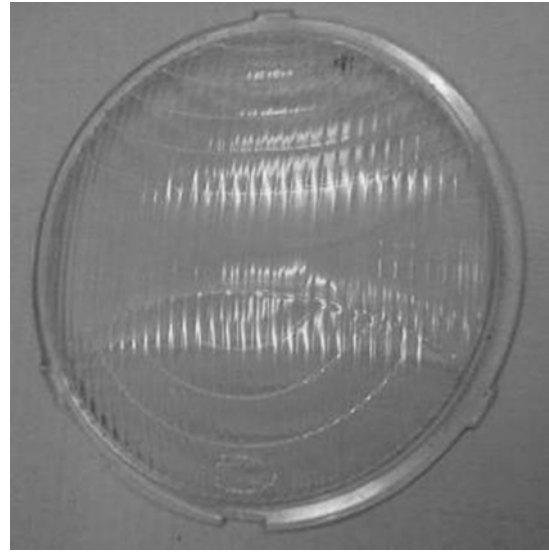
Page 19 A second version of the Ford of France Marchal headlamp and a Ford of Britain script “Depressed Beam” headlamp lens. (Lincoln motor cars of the period were equipped equipped with Depressed Beam headlamps).

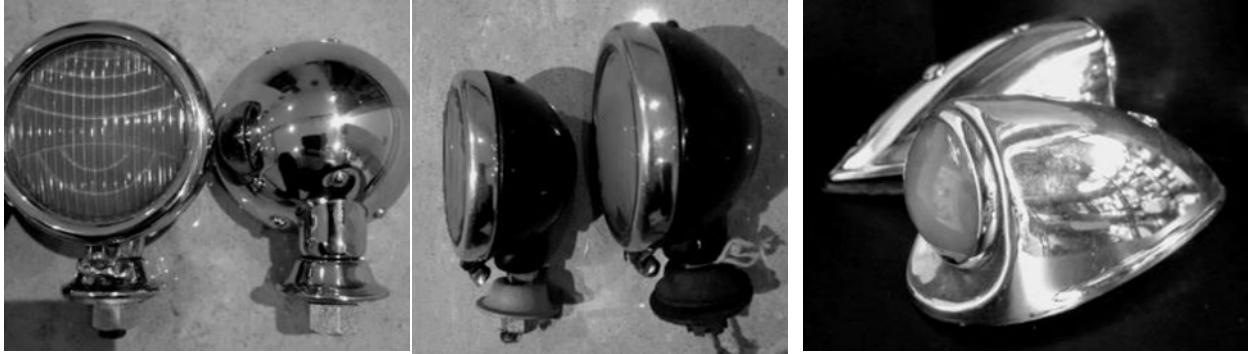
Page 21 Ford of Britain passenger car and commercial vehicle Depressed Bean fender lamps and Model 14 fender lamps.

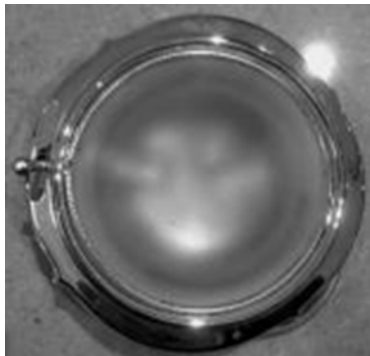
Page 27 Dome lamp used in Briggs-built Tudor and Fordor saloon bodies in Europe.

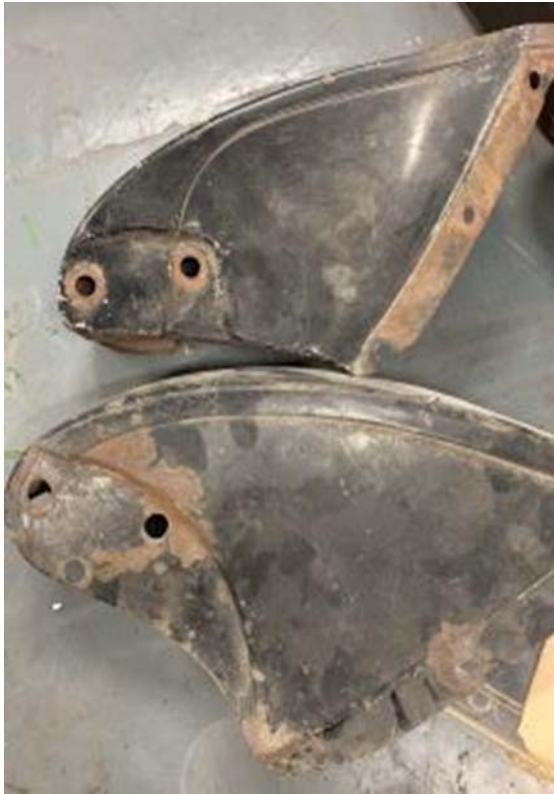
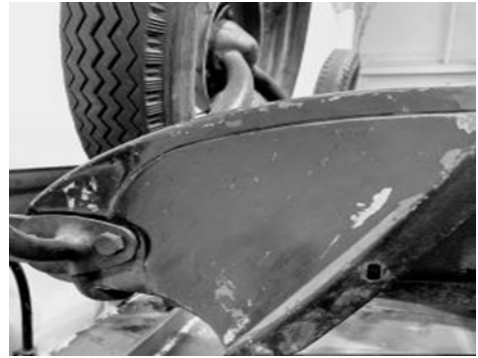
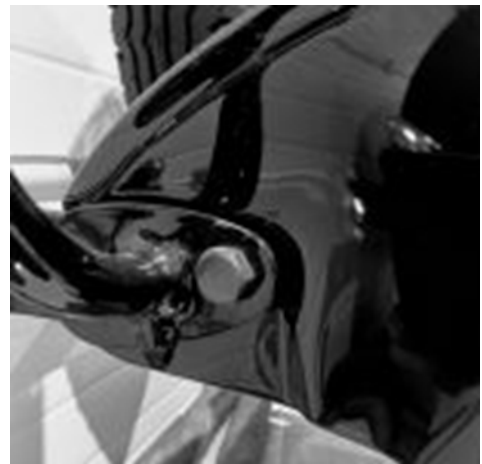
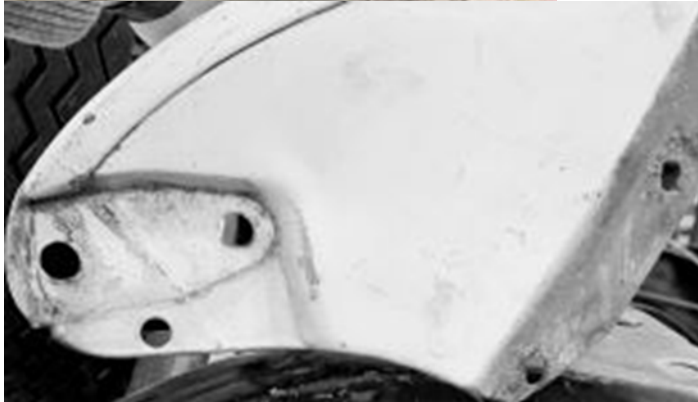
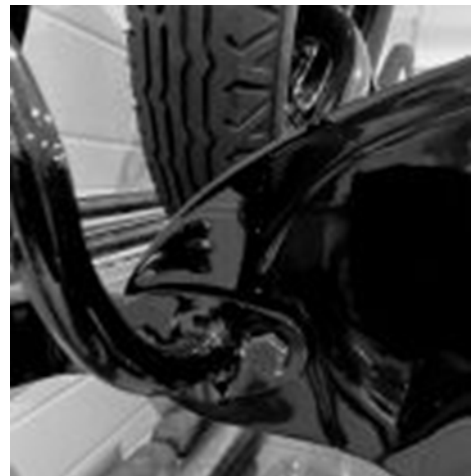
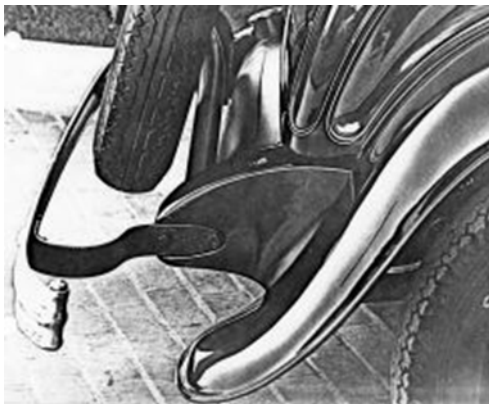
Chapter 7 Page 8 The seven known variations of rear frame horn covers.

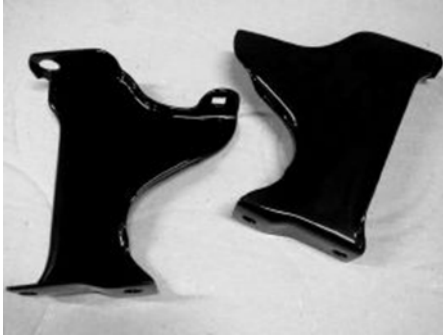
Page 10 B-400 convertible sedan and B-190 Victoria-only rear running board brackets.

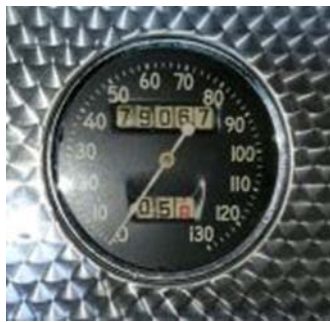
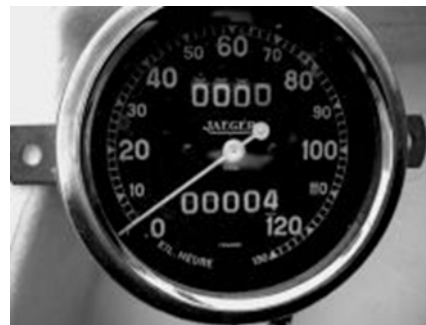
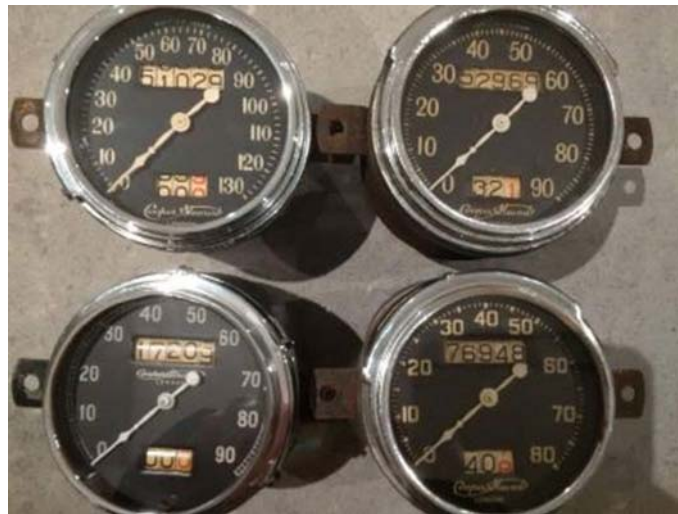
Chapter 8 Page 2 U.S.-made 130 KPH, French Jaeger 120 KPH, and various British Cooper-Stewart MPH and KPH speedometers.

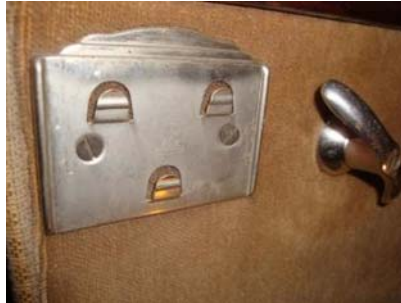
Page 30 One of two versions of the mounting plate for the ash trays in the rear compartments of deluxe sedans, Victorias, and convertible sedans and on the doors of cabriolets. The other version has V-shaped raised slots.

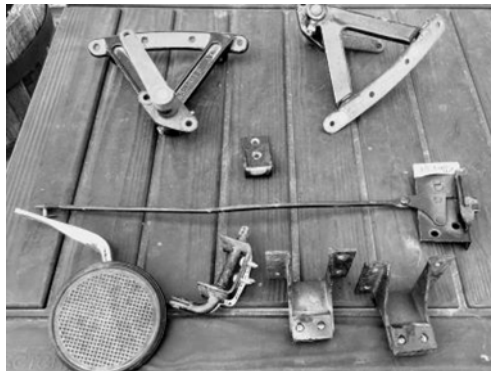
Page 48 B-520 deluxe coupe rumble lid hinge and latch components. (The stamped guard for the latch tongue is bent downward 90 degrees from its original position on the latch in this photo.)

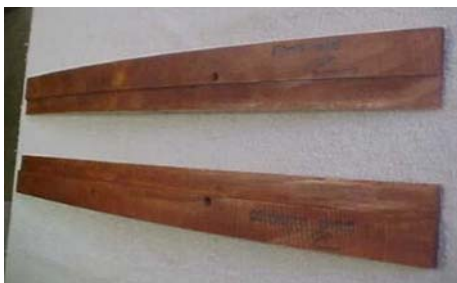
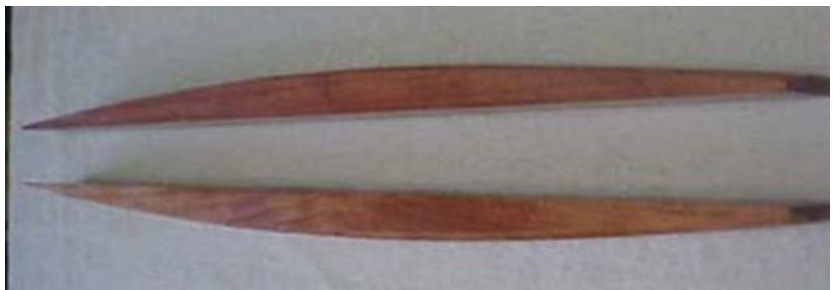
Chapter 15 Page 2 B-520 deluxe coupe seat sight shield wood that was covered with trim panel fabric and attached to the B pillars to fill the gap between the curved pillar and the straight side of the seat frame.

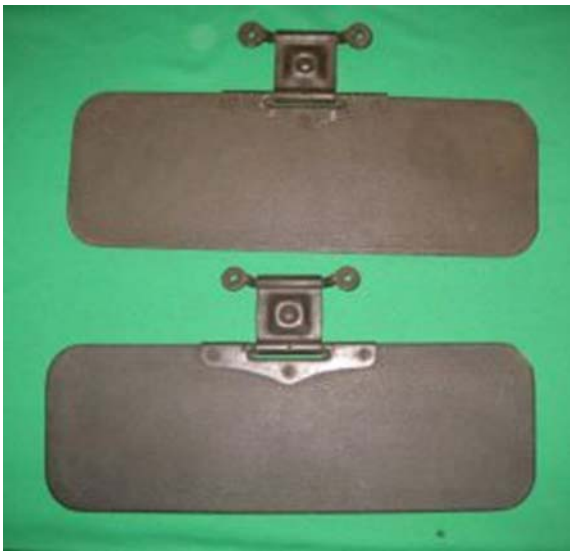
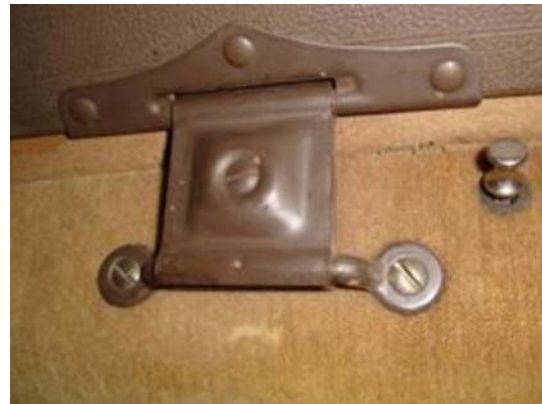
Chapter 11 Page 23 All but late North American closed car sun visors (except deluxe coupe) and a close up of their double-hinged attachment bracket.

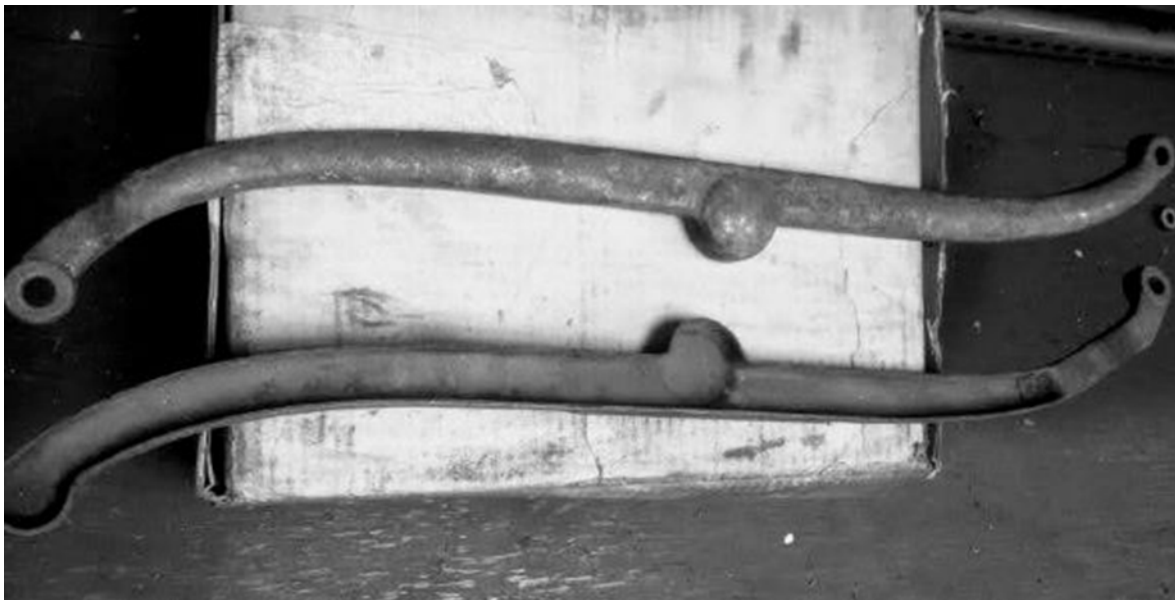
Page 27 B-50 sport coupe landau irons.

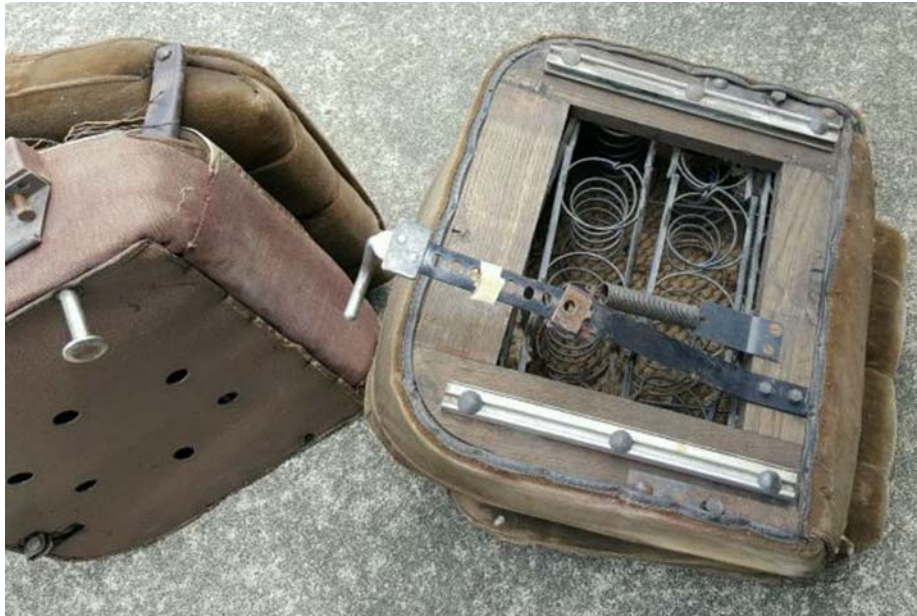
Page 4 B-55 Tudor sedan, B-190 Victoria, and B-400 convertible front seat bottom details.

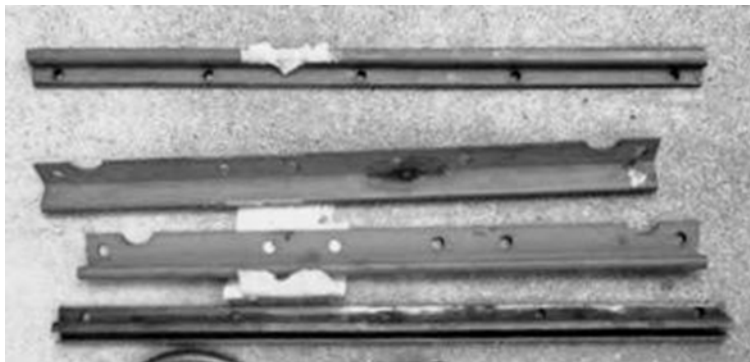
Page 6 B-520 deluxe coupe seat tracks (originally cadmium plated).

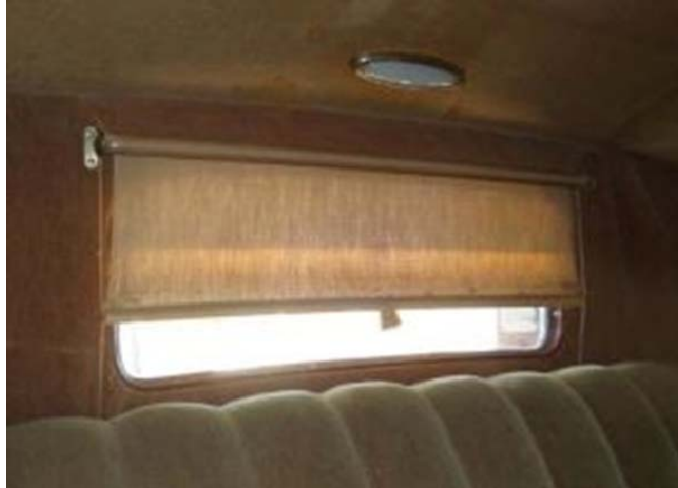
Page 8 Typical closed car rear window shade, except for a tassel and looped cord used on B-520 deluxe coupe shades rather than a sewn-on tab as on this example. Note the guide cords on the sides threaded through eyelets on the ends of the bottom wood insert.

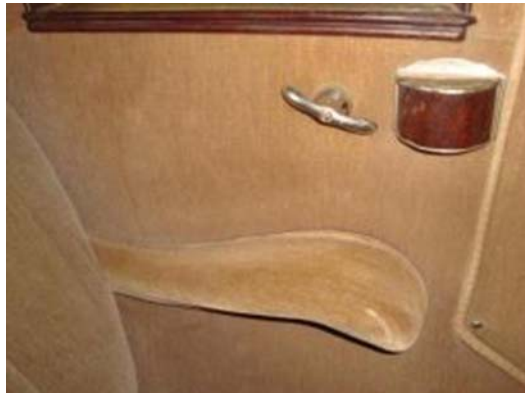
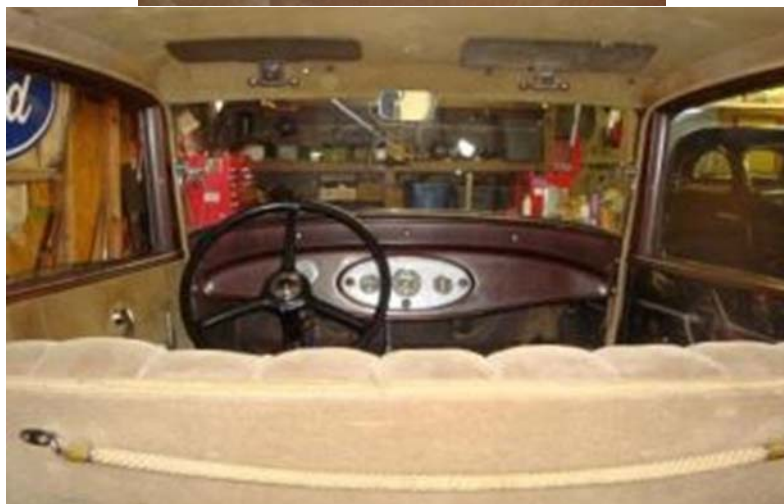
Page 9 Placement of the arm rest and ash tray on B-160 deluxe Fordor sedan quarter trim panels and robe rail on the back of the front seat.

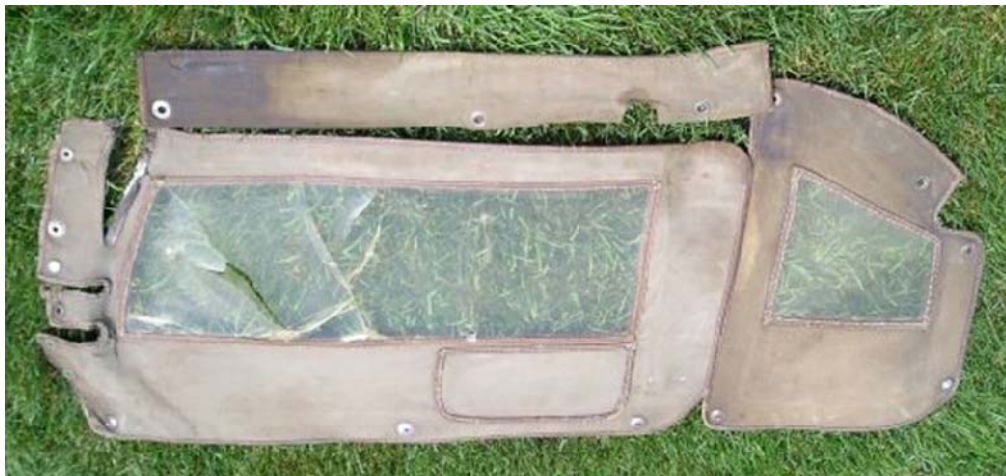
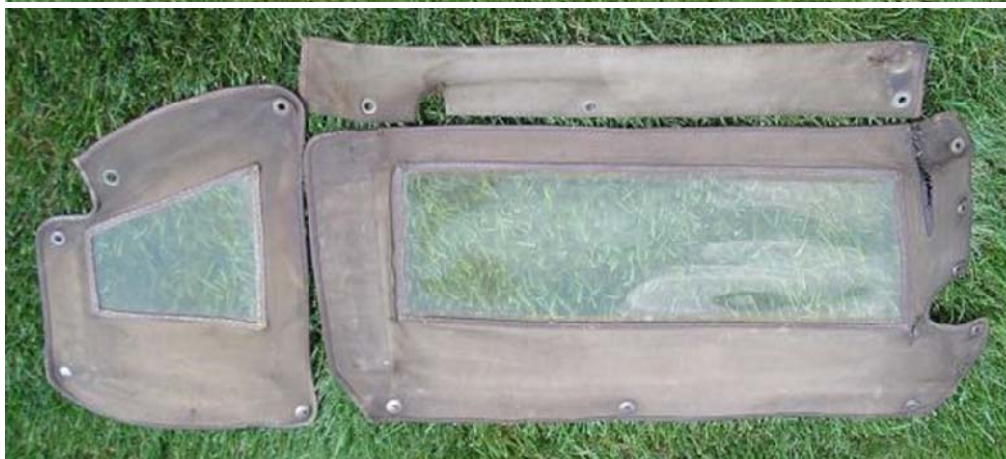
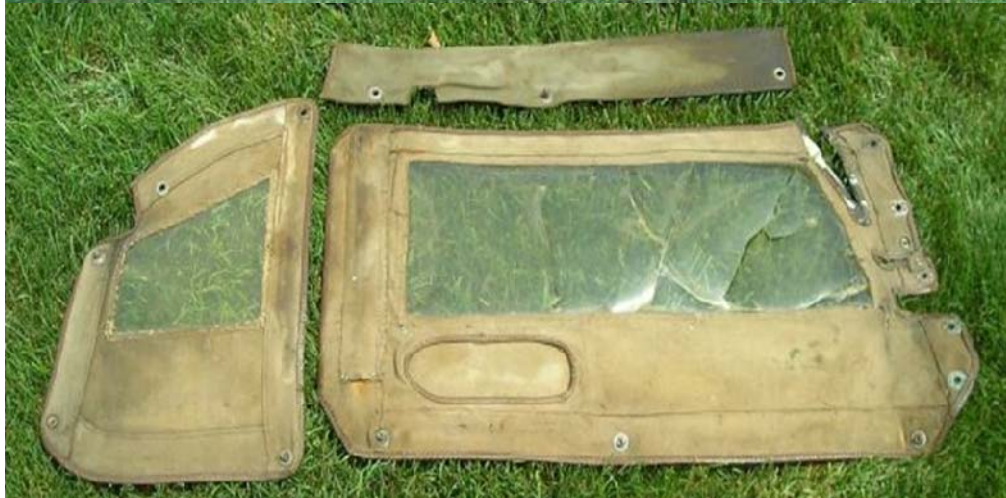
Chapter 17 Page 11 The photos of the B-40 standard roadster side curtains on this page in the book did not include the quarter curtain. The following photos are of a complete set of original B-40 deluxe roadster door and quarter side curtains. The standard roadster quarter curtains are identical to the deluxe roadster quarter curtains except for the fabric used for their construction.

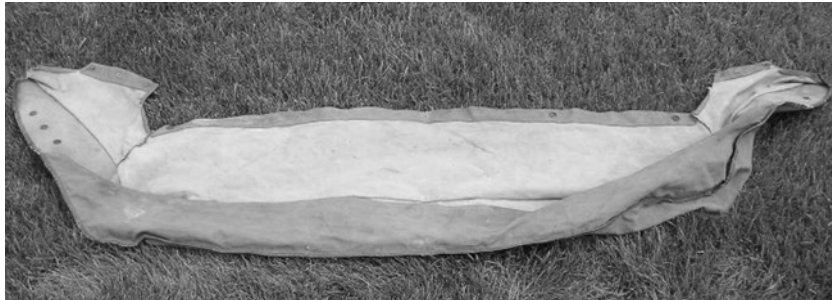
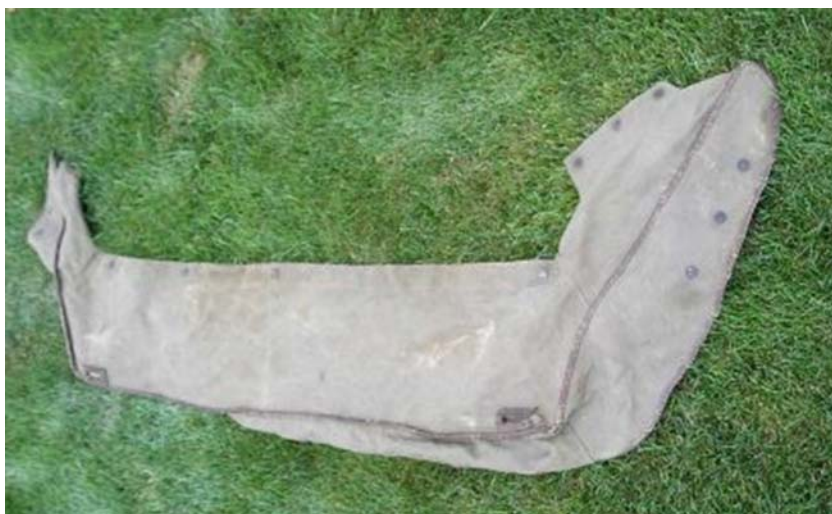
An original B-40 deluxe roadster top boot is shown in the next two photos. Additional photos of the roadster top boot installed are shown in Volume 2 on pages A-1-3 and A-1-4.

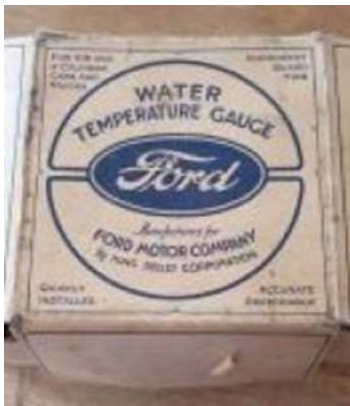
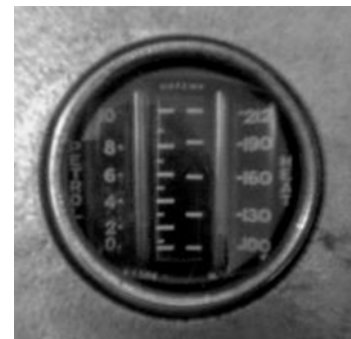
Chapter 19 Page 4 Shown in the photos below are an example of the box for the Ford-authorized accessory King-Seeley combination fuel and temperature gauge and the installation instructions that were included in the box. The instructions detail the routing of the temperature gauge sending tubing throughout the engine compartment, etc. For the 1932 models, this extra-cost accessory was only available as dealer-installed. The third photo shows the face of the British version of the combination fuel and temperature gauge.

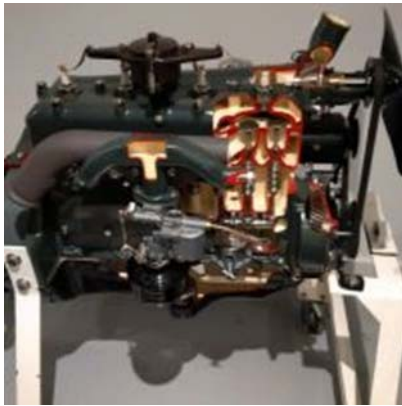
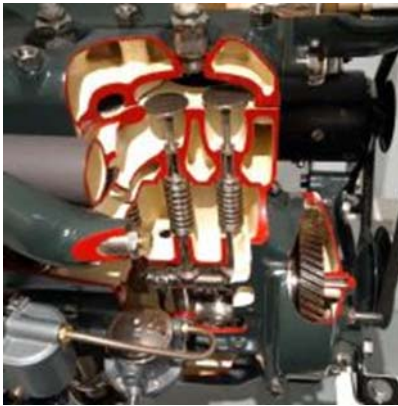
The following additions to this Appendix are as follows:
three views of restored components of a surviving original Ford of Britain four-cylinder display chassis and a period newspaper article regarding the chassis, a Ford Werke (Germany) show-room photo of the front end of one of their semi-custom cabriolets (note the flat headlamp lenses, unique horn, and body-colored fenders), another example of the one of the several versions of German semi-custom cabriolets.

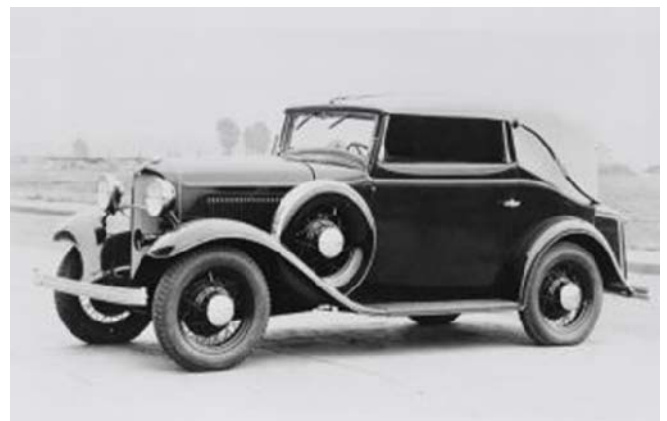
ENGINEERS AND THE ENGINE: Members of the Women's Engineering Society recently visited the great Ford motor factory at Dagenham, Essex, to watch the manufacture of British cars and commercial vehicles. Some of the party are seen examining a special exhibition chassis of the 14.9 Ford

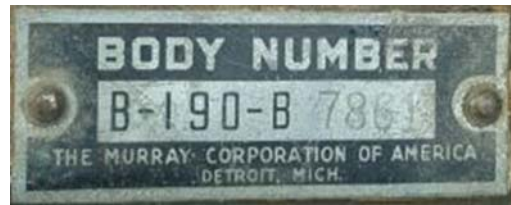
Appendix 8 Page 2 Body tags from a station wagon, a Ford Werke semi-custom cabriolet, and a Victoria.

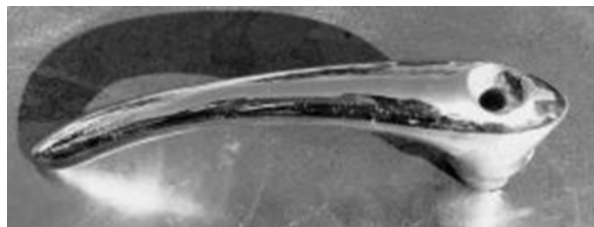
Appendix 11 Page 17 A late B-520 deluxe coupe rumble lid latch release handle.

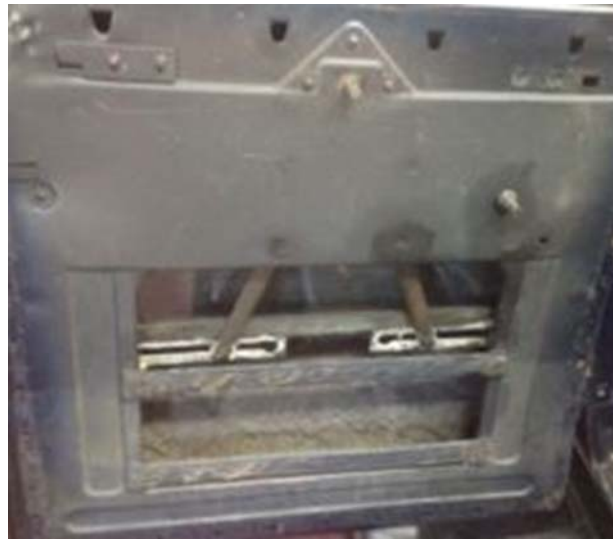
Page 10 of 15

The cabriolet door shown in the photo on this page is incomplete in that the two horizontal channels that span the large opening in the center of the inner door panel have been removed. The photo below is of a cabriolet door with those two horizontal channels in place. Other than being of a unique length, they are identical to the channels in all of the '32 closed car and convertible sedan doors. A cabriolet has no door pockets, unlike the closed cars and convertible sedan, so the channels do not serve as the foundation for door pockets, but rather serve to back up the cardboard door trim panels.
