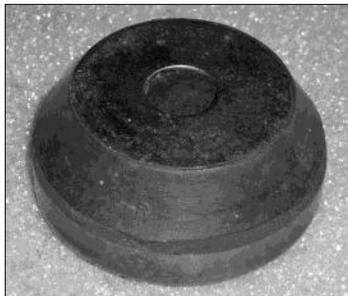
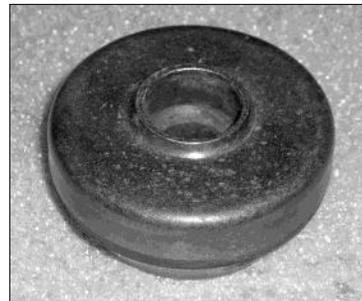
Page 25 What likely is a rare B-6038-B engine front insulator has recently shown up in NOS form. It would have preceded (and very briefly so) the familiar B-6038-C insulator which was initially used with a separate B-6049 stamped seat. The B-suffix version looks just like the C-suffix version except that it has its own integral stamped steel bottom or seat with the same outside diameter as the rest of the insulator. Like the separate B-6049 seat, the hole in the steel bottom of this insulator has a lip to fit into the 29/32" holes in a 'flat' front cross member. Based on my experience, this insulator (shown below) is even rarer than the original B-6038 shown on page 24.

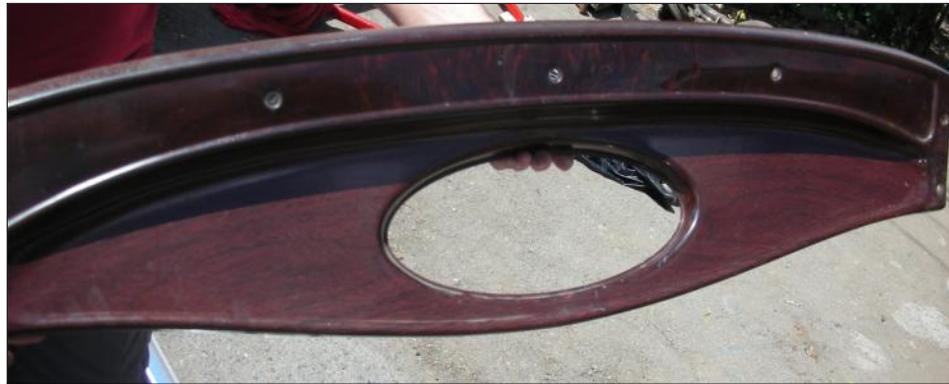
Page 29 On deluxe closed cars (except the deluxe coupe) and the cabriolets and convertible sedans, the early straight wood grain pattern was a combination of straight grain on the lower portion of the front belt rail finish panel (dash) surrounding the opening for the instrument panel and burl grain on the upper portion where the panel is attached to the cowl. The early grain pattern for deluxe phaeton and roadster panels was entirely straight grain.

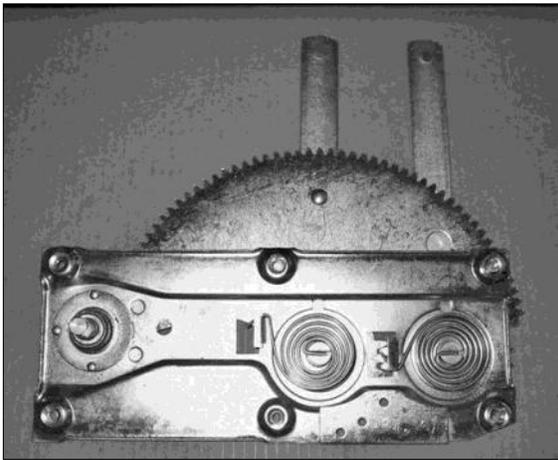
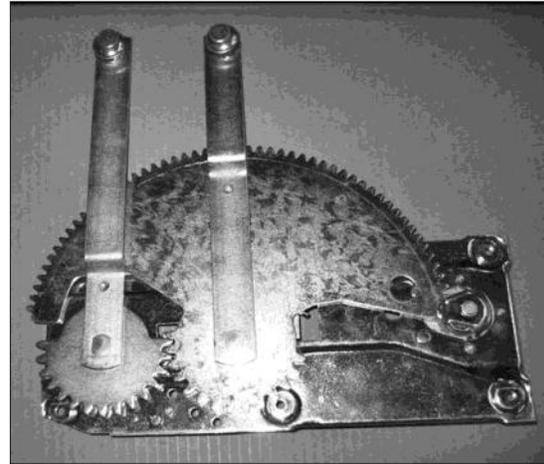
B-194200 window regulator

The window regulator shown above and in Appendix 8, B-194200, carries a Victoria body part prefix which suggests that it was first released for the Murray-built bodies, namely the Victoria, convertible sedan, and deluxe coupe. Given the order in Ford's part numbering system, logic would dictate that if a window regulator fit all of the closed cars, as does B-194200, it would carry the prefix of the body with the lowest assigned body number, namely B-45, the standard coupe. This too suggests that some other regulator(s) existed earlier.

The B-194200 window regulators did not require these separate stops as a threaded stop pin was incorporated into its design and three different holes were provided for the pin to afford a measure of adjustment.

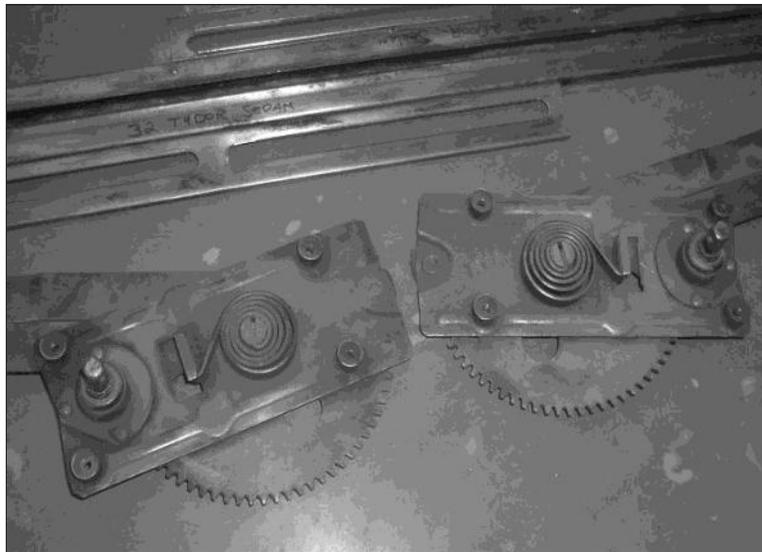
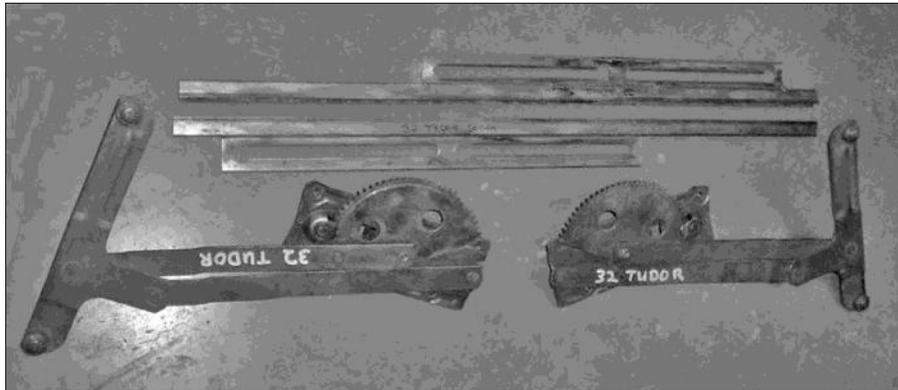
The earliest of these closed car regulators mates with the glass channels like B-45692-AR (shown in Appendix 8) with the 'key holes' in the one-piece lower flange lined up the same way. These regulators had two gears, a single coil spring, and two arms that were connected at their outer ends to a T-shaped stamping to which the two rollers and springs are attached on the ends of the top of the 'T'. Hence, unlike the later regulators, the arms of this early regulator are always approximately parallel with one another regardless of the position of the glass in the door. Also unlike all of the other front door window regulators, these early regulators attached to the door inner panels in four places in a vertical position.

The design of this regulator required separate sash stops attached to the door inner panel. These (2 per door) were triangular-shaped stamped brackets into which a rubber bumper such as B-46570 (also shown in Appendix 8) was inserted. The brackets were riveted to the inside of the door inner panel.

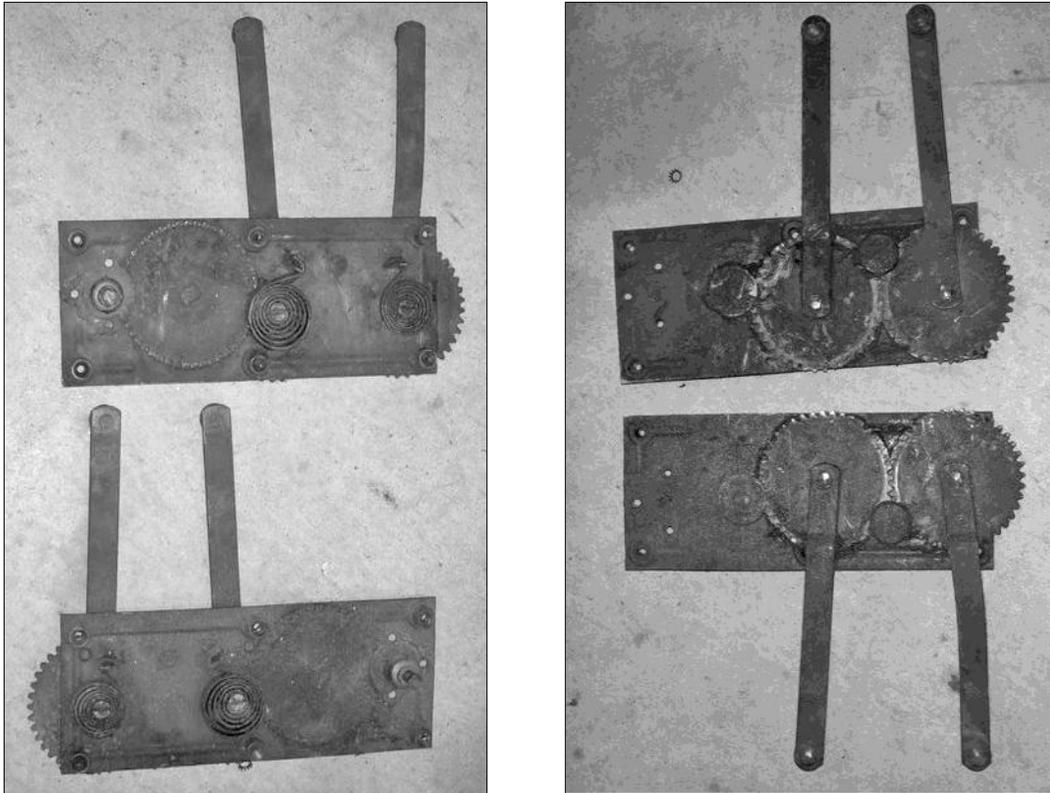
Initial horizontal window regulators

The other regulator design used prior to B-194200 had five gears, two coil springs, and arms that moved in opposite directions when operated (like B-194200). The regulator attached to the inner door panel in six places in a horizontal position. This type of regulator was used with steel glass channels that had two separate 'key hole' flanges with their holes and slots lined up opposite to one another such as B-45962-B (also shown in Appendix 8).

This 'horizontal' regulator design also required the separate sash stops described above.

Note that all three of the above regulator designs have countersunk threaded spacers to accept the four or six #12-24 slotted flat head attachment screws. Some '33 regulators look like the initial version of the '32 horizontal regulators, but they lack these threaded spacers.

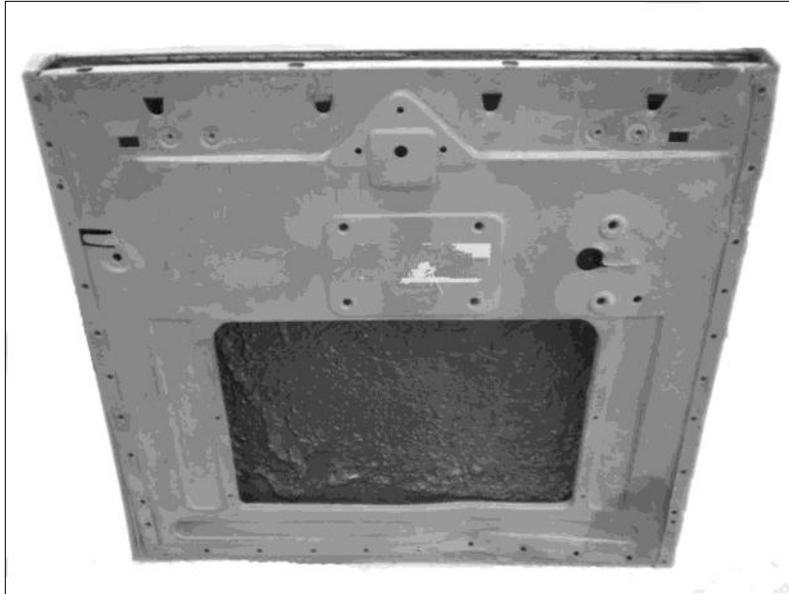
Cabriolet inner door panel

In the following photos of the inner panels of a cabriolet door, a deluxe coupe door, and those of a Fordor and Tudor, note that the hole pattern in the cabriolet door and deluxe coupe is such that only the 6-attachment point 'horizontal' regulators could be installed. In either of the Fordor and Tudor doors, either the 'horizontal' or the 4-attachment-point vertical regulators could be installed. The same applies to all of the standard/sport coupe door inner panels that I've seen.

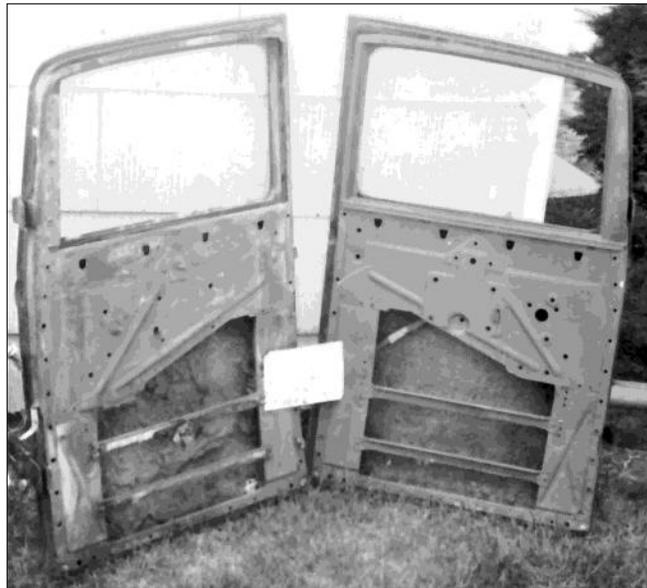
Early (left) and late Fordor inner door panels

In the photo on the right of a late Tudor door, note the B-194200 regulator (with the large diameter gear) and the six unused holes in a vertical row on either side of the opening for the map pocket. These are for the stop brackets mentioned above, but in this case those brackets were not required. In the photo with the two Fordor doors these brackets are installed along with a 4-attachment point vertical regulator on the door on the left.
